> Powertech Labs Inc.

# CNG & Hydrogen Tank Safety, R&D, and Testing

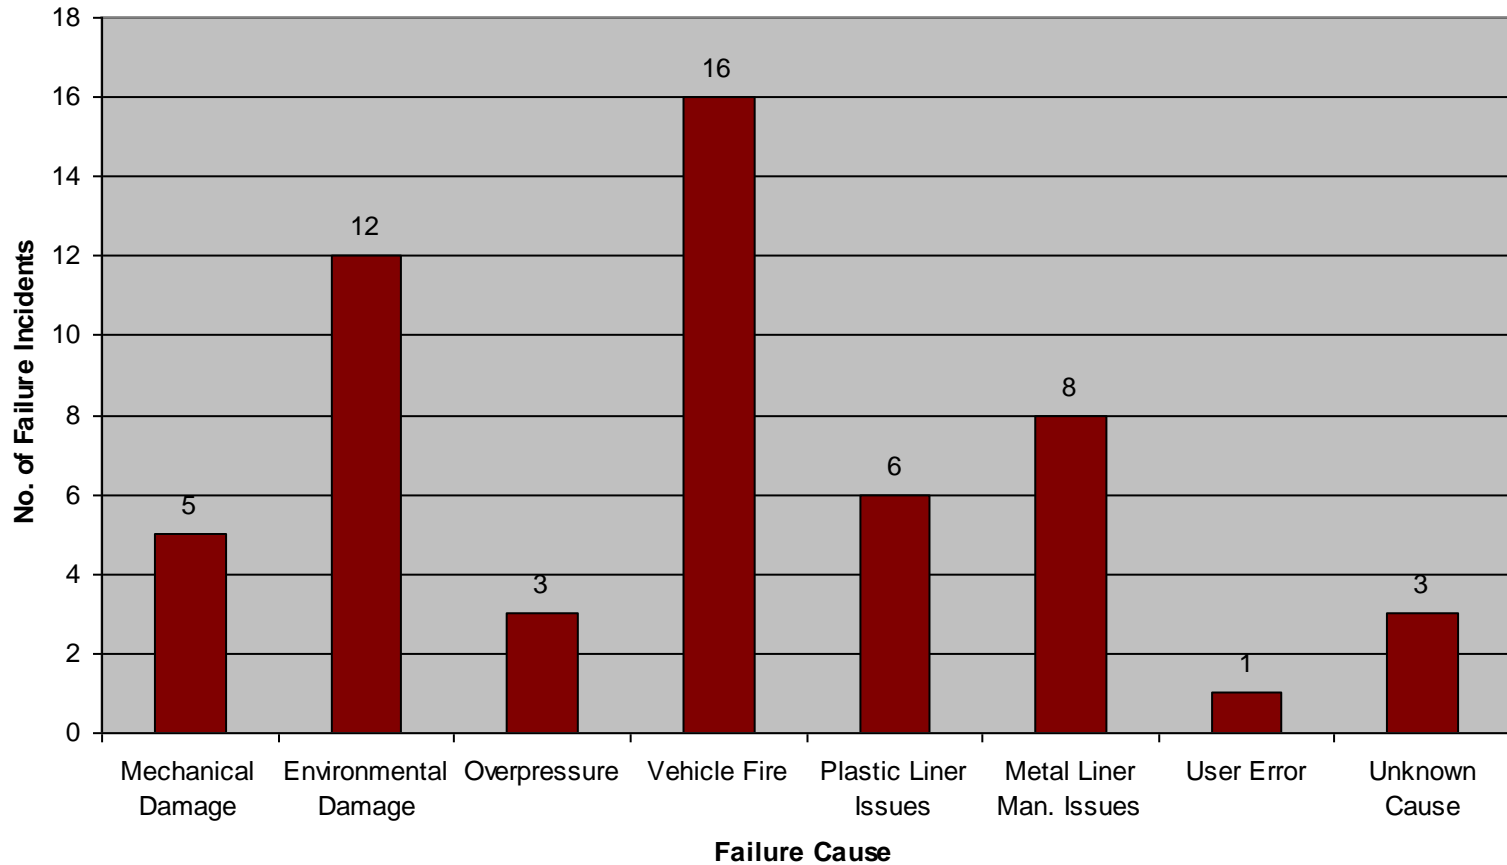
# FAILURE INCIDENTS REPORTED BY FAILURE CAUSE

Data classified according to eight unique failure causes:

- Mechanical Damage – External abrasion and/or impact
- Environmental Damage – External environment assisted, typically SCC
- Overpressure – Faulty fueling equipment or faulty CNG cylinder valves
- Vehicle fire – Faulty PRDs or lack of PRDs; localized fires
- Plastic Liner Issues – Man. defects incl. cracking at end boss/liner interface, flawed welds, liner seal failures
- Metal Liner Issues – Man. defects incl. pinhole leaks, laminations, poor heat treat practice

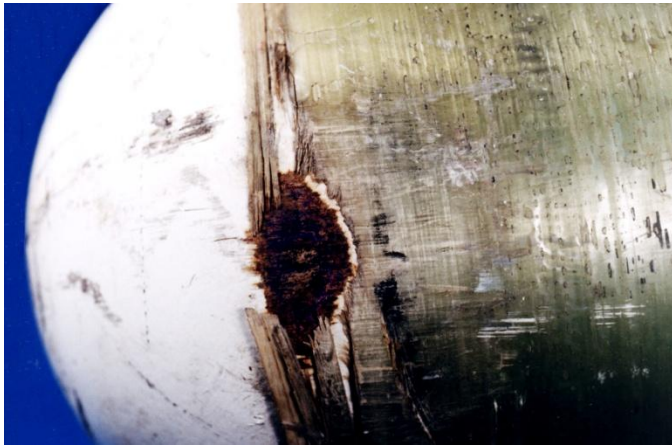
Tank dragged on road under vehicle after support strap broke.

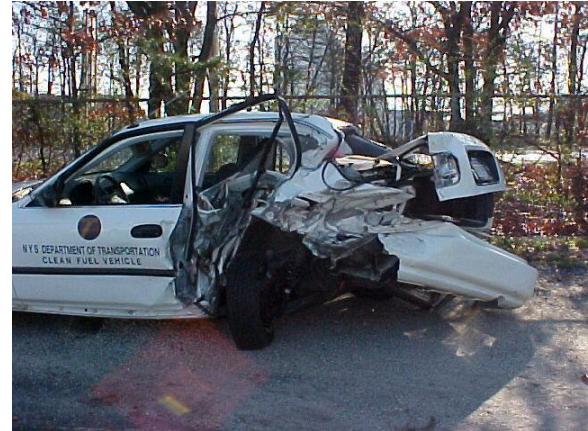
CNG vehicle crash – no tank rupture

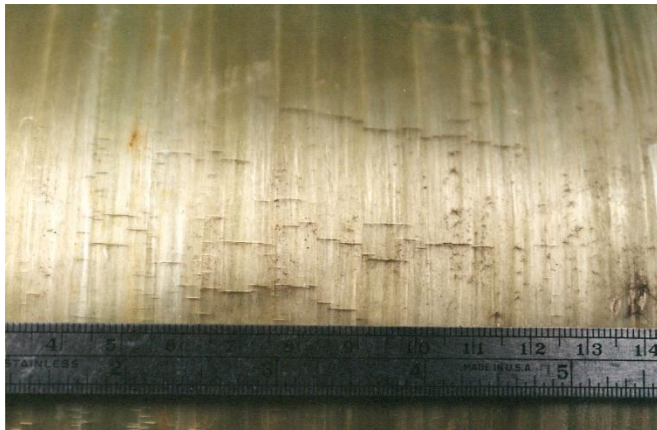
Stress corrosion cracking due to acid attack on fibers

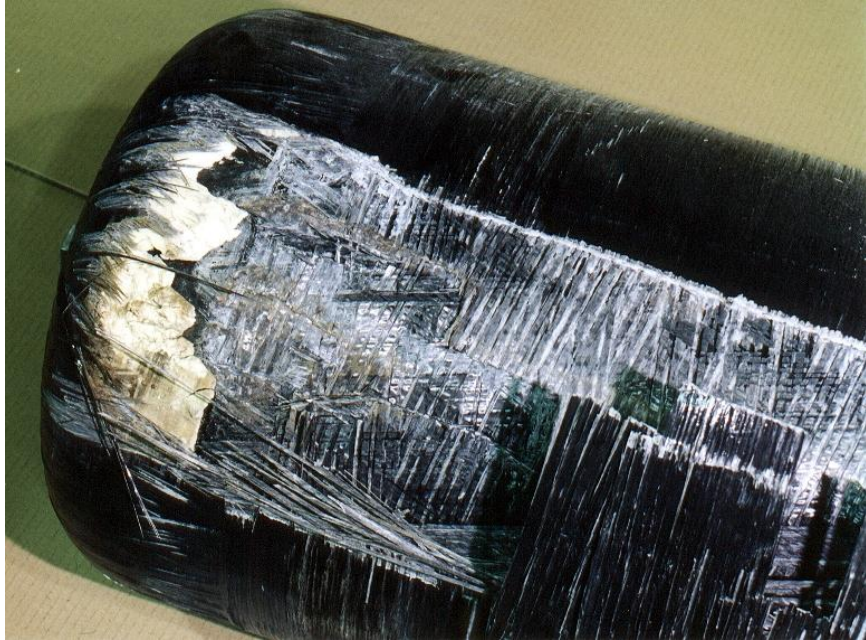
Tanks mounted on CNG bus roof. The bus impacted a low overhead, collapsing the roof. Tank still exceeded minimum burst pressure.

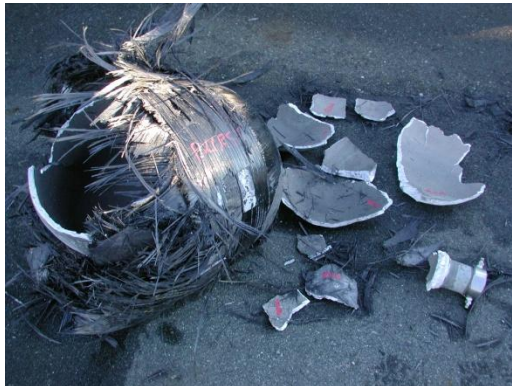
Burst Test

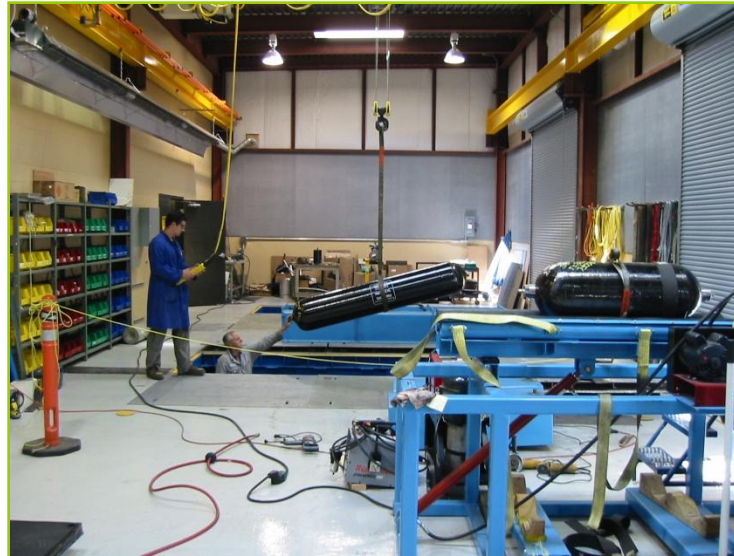
## Powertech Cylinder Test Facilities

- Burst test up to 2,800 bar
- Hydraulic pressure cycling up to 1,500 bar

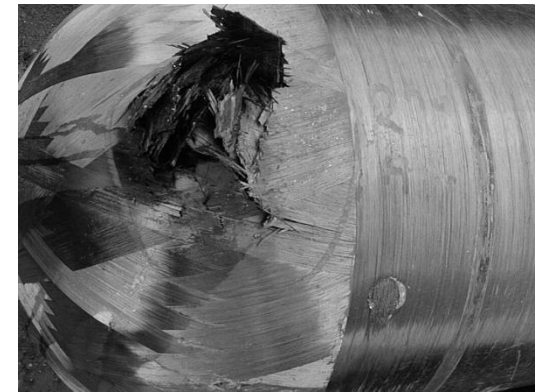
Drop Test

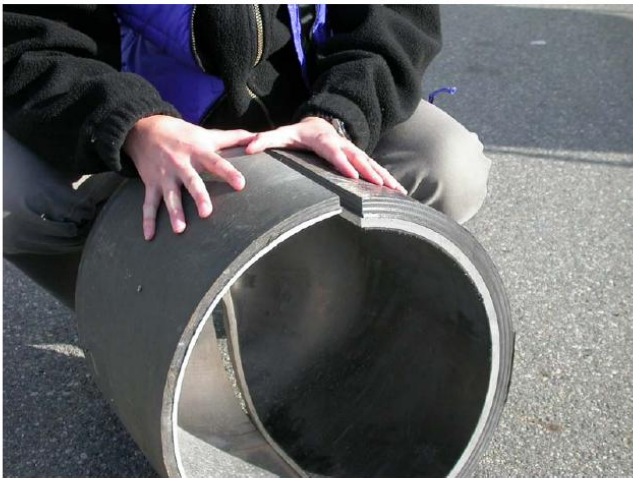
Wall thickness comparison - 35 MPa vs 70 MPa cylinders

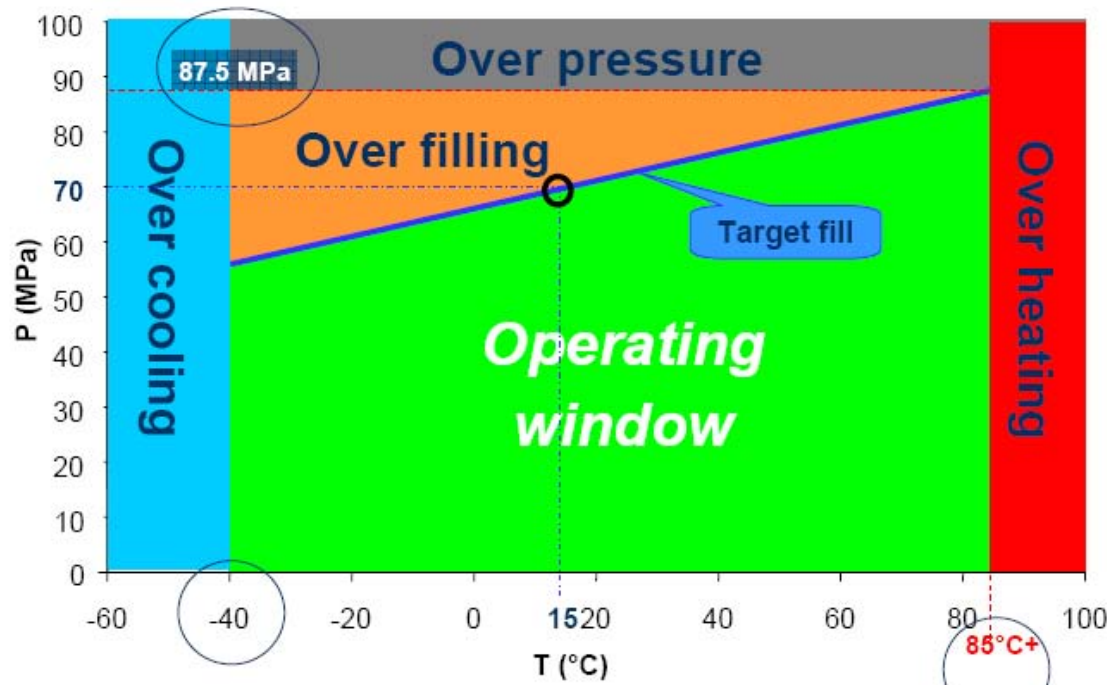
# Filling Conditions with Hydrogen

- How to ensure a “full” fill?
- Heating of H<sub>2</sub> during filling
- 700 bar @ 15C and 875 bar @ 85C
- Communication between vehicle & dispenser?
- Flow control?
- Pre-cooling of gas?

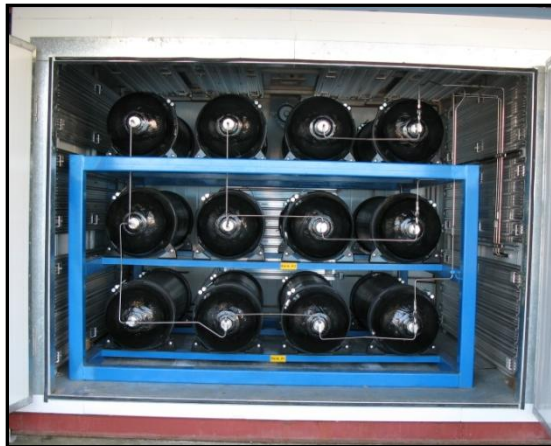
Ground Storage Chamber  
875 bar -40C to +50C
